historic structure report
the main building

ELLIS ISLAND
STATUE OF LIBERTY

NATIONAL MONUMENT/NEW YORK-NEW JERSEY

**Beyer Blinder Belle/
Anderson Notter Finegold**

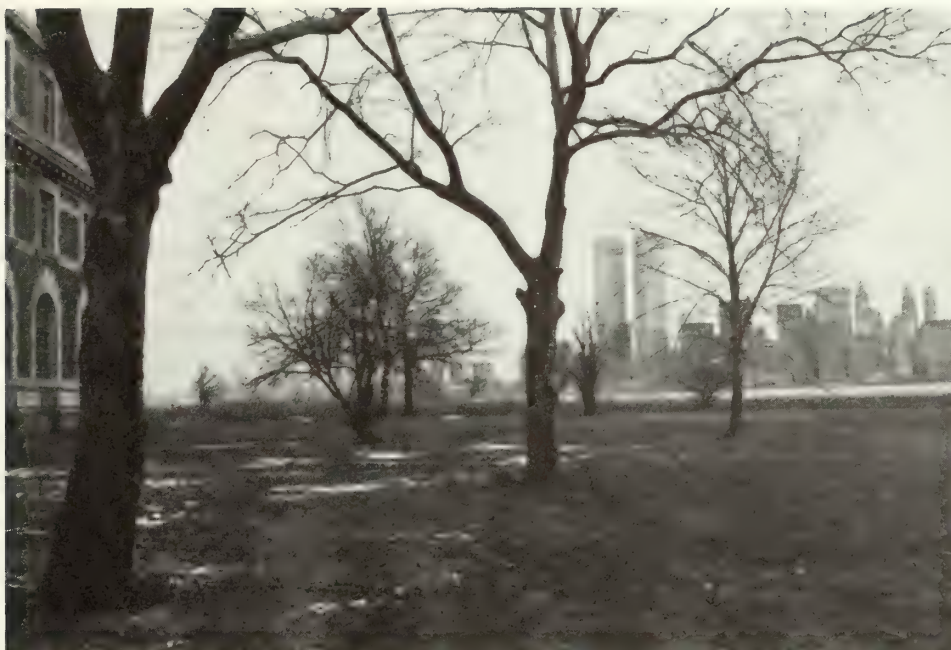
In 1898 Boring and Tilton recommended raising the grade of Ellis Island for the main building "two feet above the present level." That grade has been maintained ever since (photo 13). The terrain does pitch away from the building slightly in most cases, but this is in obvious evidence today only by viewing a bluestone retaining wall at the western end of the kitchen and laundry building (photo 14). Grading was done in front of the main building and on island 2 circa 1902. Grading of island 3 was undertaken in 1912. The last landfill areas between islands 2 and 3, the northeast corner of island 1, and the 1935 landfill around the new immigrant building were all graded in 1935-1936. In general, there are no topographic features except for the aforementioned bluestone retaining wall dating from 1902. The major topographic characteristic of the landscape is its seemingly flat appearance. Overall, the condition of the topography is stable. Several sinkholes around the seawall have developed and are expanding (photo 15).

13. Flat terrain, east end of island.

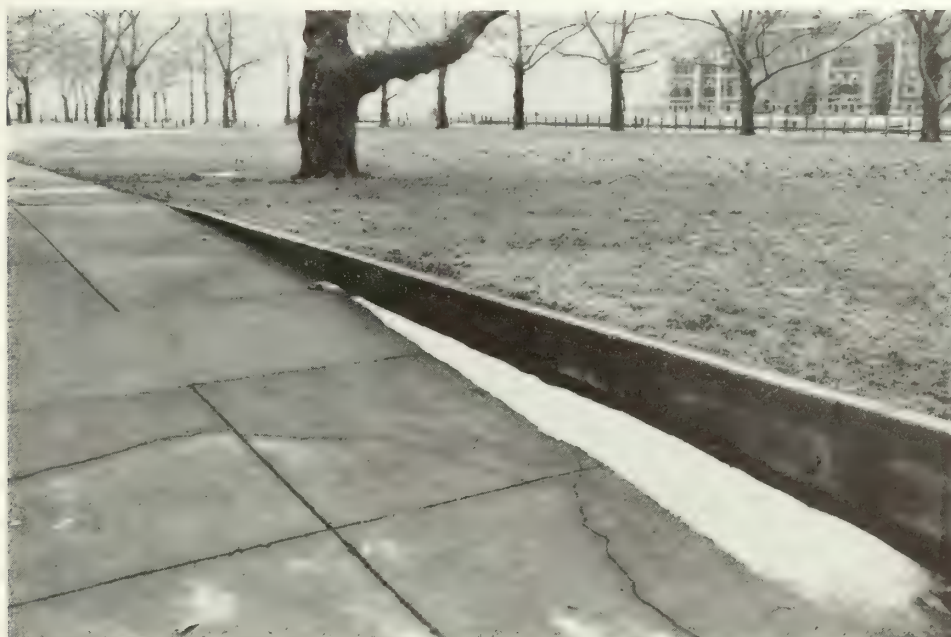
14. Bluestone retaining wall, west end of kitchen and laundry building.

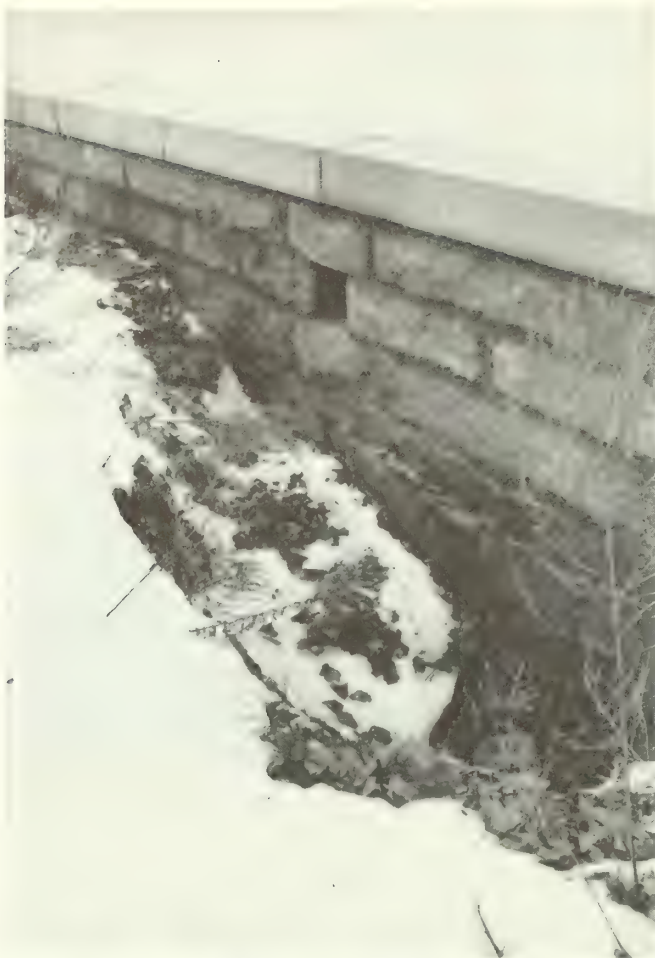
15. Sinkhole along seawall.

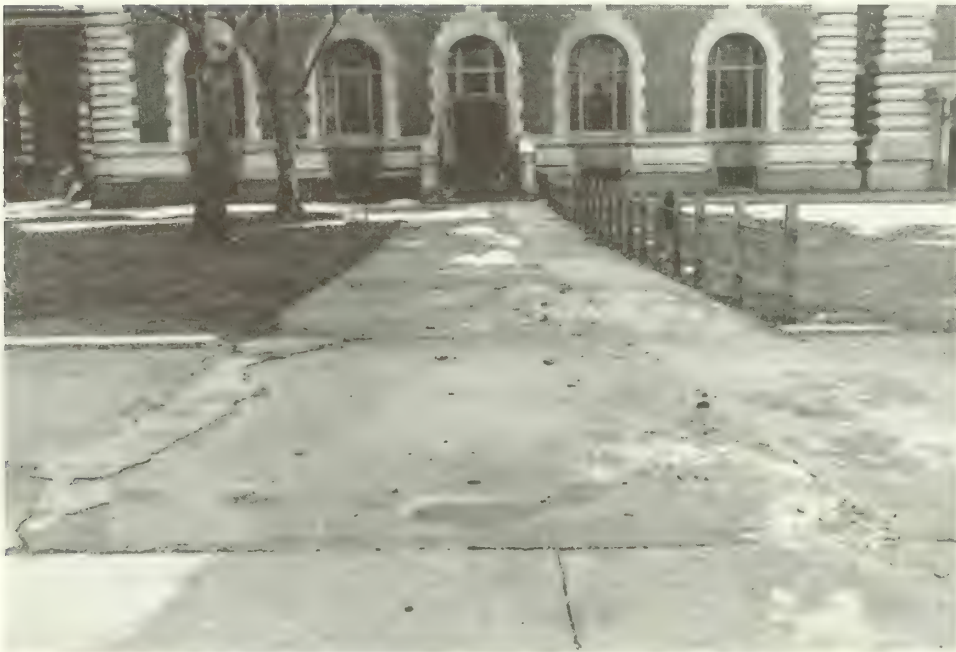
The 1903 path layout is still retained in front of the western end of the main building and in front of the kitchen and laundry building (photo 16). The rest of the island 1 path layout dates from 1937, including the walk in the front of the eastern half of the main building, and

16. The extant 1903 path layout, west end of main building.

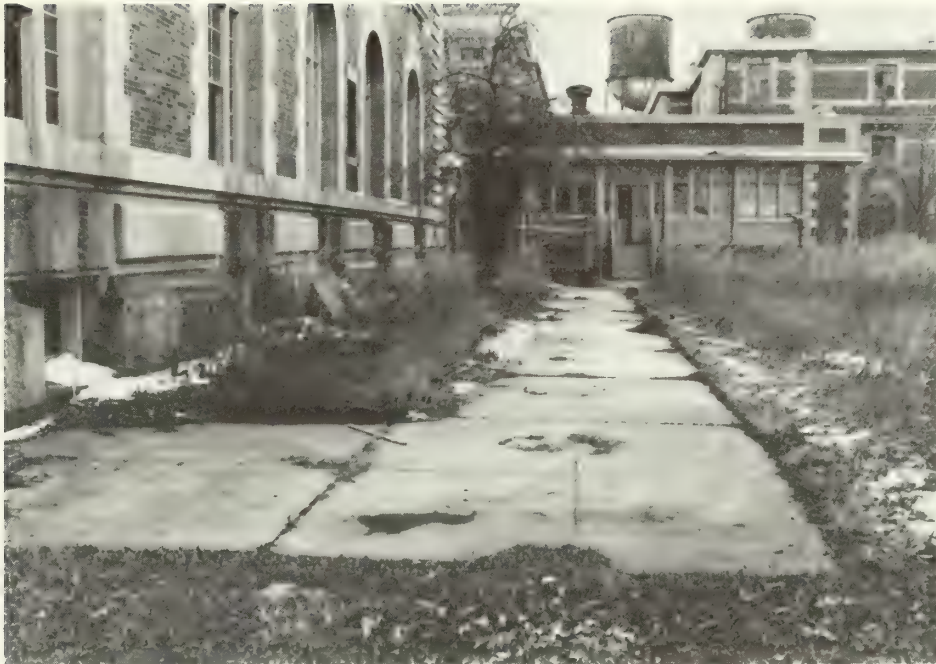
the walk around the rear of the main building and along the east side of the baggage and dormitory building (photo 17). These are the only extant walks on island 1.

17. Walk around the rear of the main building.

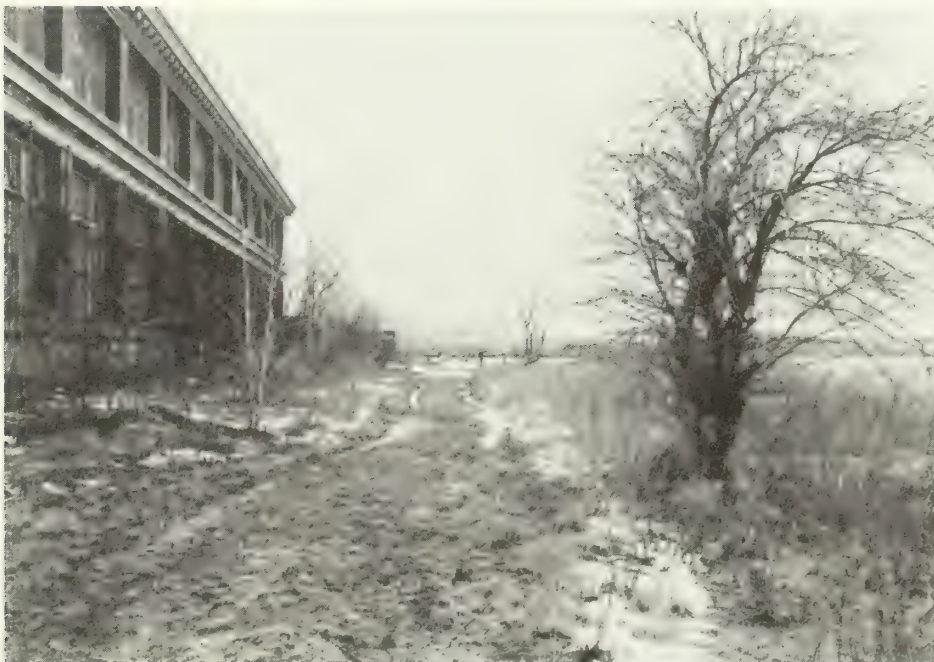
Other than dirt "desire lines" (shortcut paths visible because of their wear on grass or planted areas) (photo 18), the Ellis Island landscape has had boardwalk, cinder, and concrete paths. Of the three designed path types, only concrete paths and a small amount of boardwalk near the greenhouse (photo 19) are extant. All the paths mentioned under "Path Layout" are concrete. In a 1937 specification for new paths on island 1, the paths were to be five inches thick "in about 4 foot squares" with 3/8" expansion joints not over 20 feet apart, reinforced with a wire fabric. Cinder remnants are apparent all over Ellis Island but these are probably from the landfilling operations which definitely included cinder.

18. "Desire lines", north side of baggage and dormitory building.

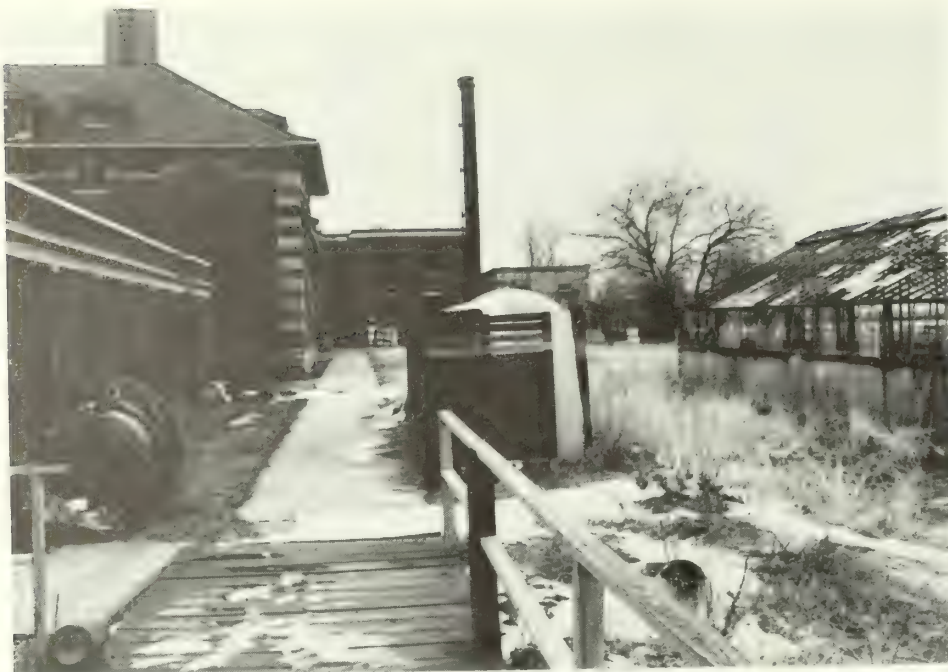
19. Boardwalk near greenhouse.

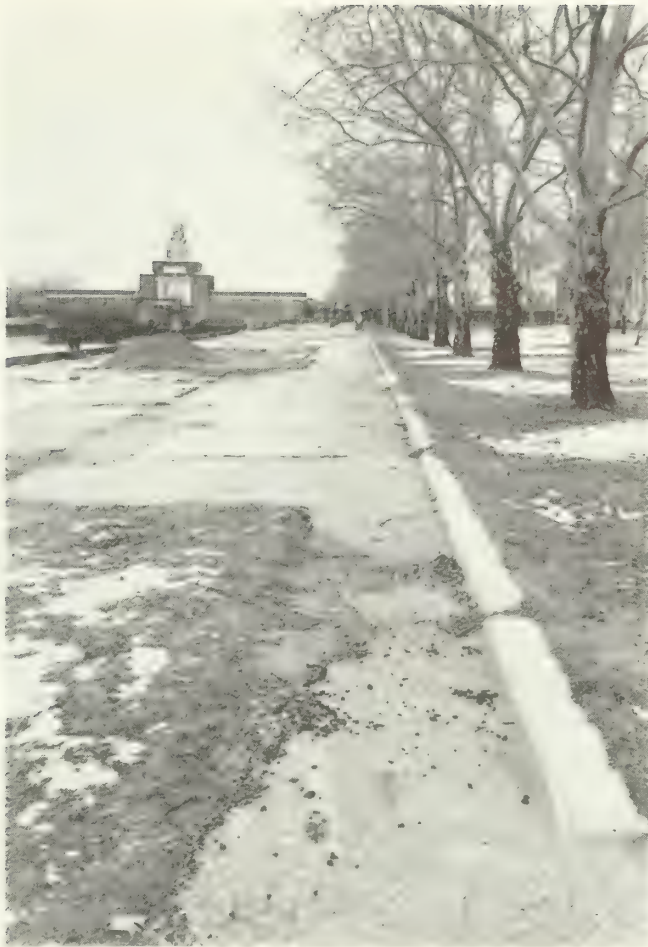
21. 6" reinforced concrete curb in front of main building.

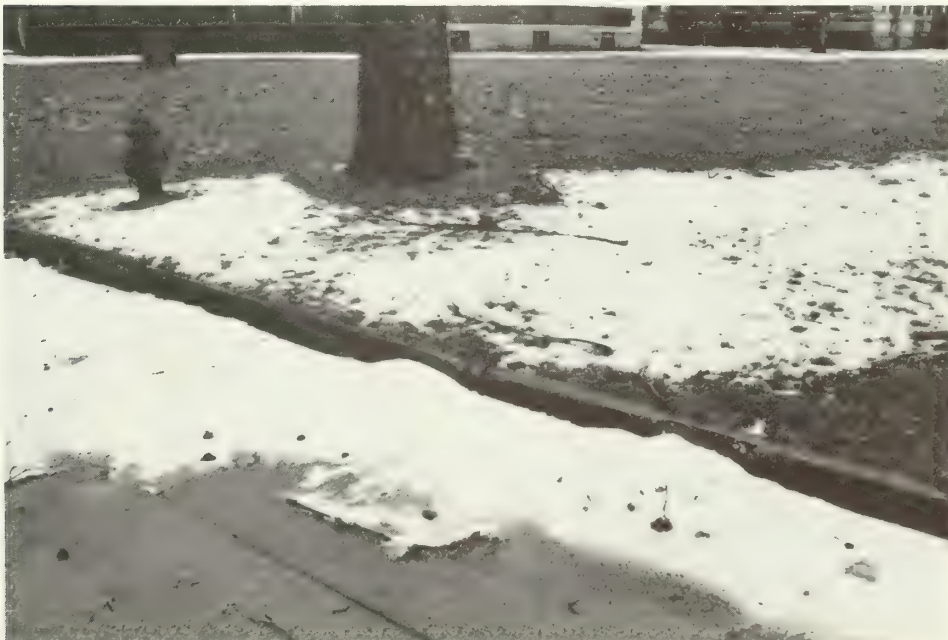
22. Bluestone curbing dating from 1902.

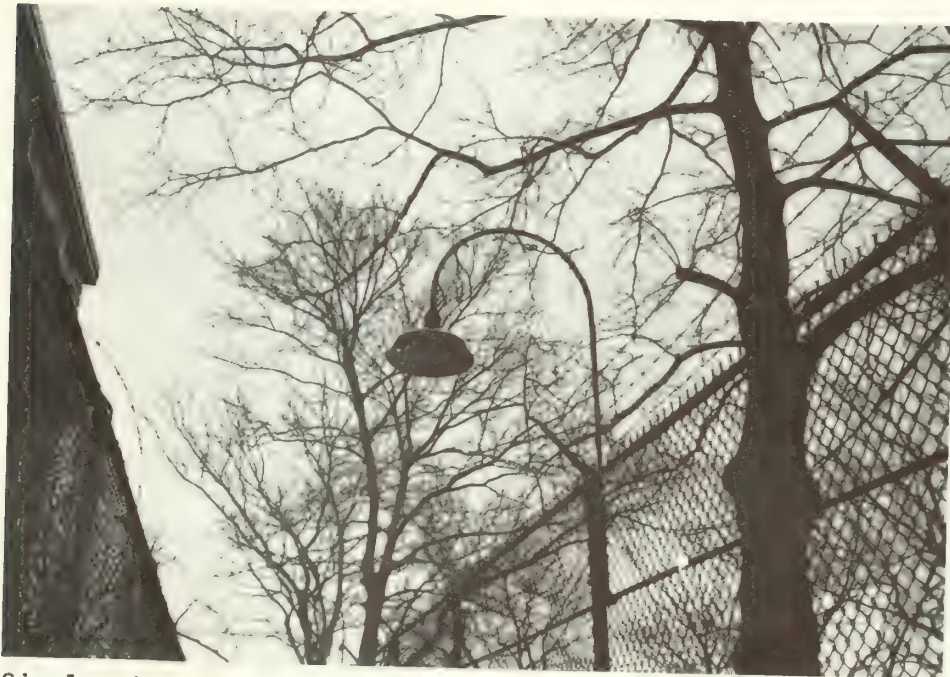
installed in the World War II detention era connected to the double row of chain link fence in front of the eastern end of the main building (photo 24). The second type of lamp is found in the central space of island 2. This is a Beaux Arts type lamp head, seemingly pre-1935 (the construction date of the landscape space), on an eight-foot octagonal concrete aggregate post that appears to be circa 1935 in style.

The tin crook-neck lamp is intact but not working. The island 2 lamp heads are intact but the reinforced concrete posts are cracked and are badly deteriorated.

24. Single tin crook-necked lamp, east end of main building.

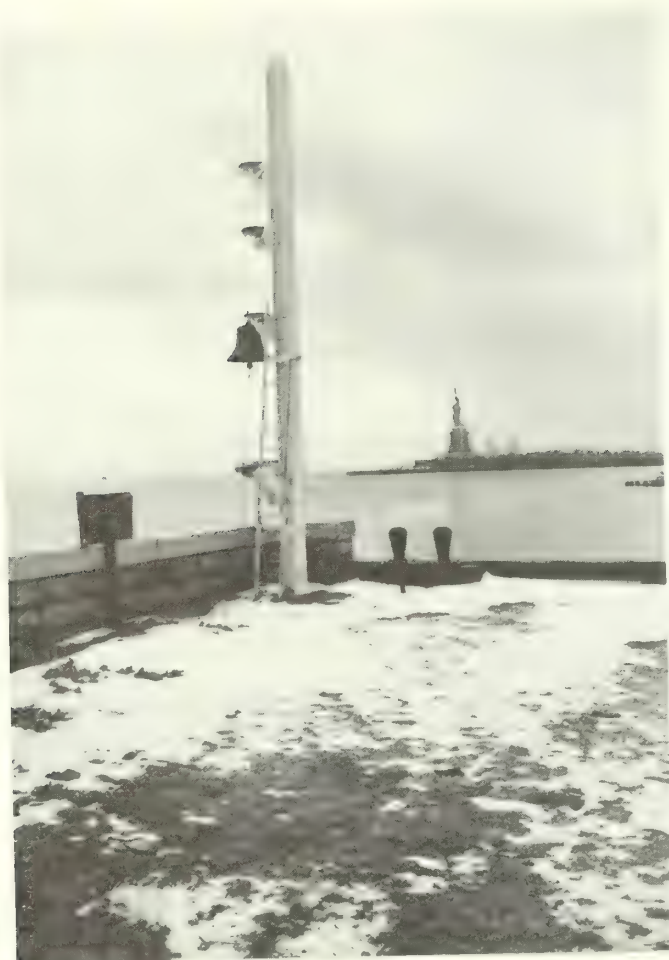
The fire bell at the southeastern corner of island 1 has probably been in that location since circa 1935. In 1913, it was located on the seawall north of its present location. The bell and its structure are in good condition (photo 25).

25. Fire bell at the south-eastern corner of island 1.

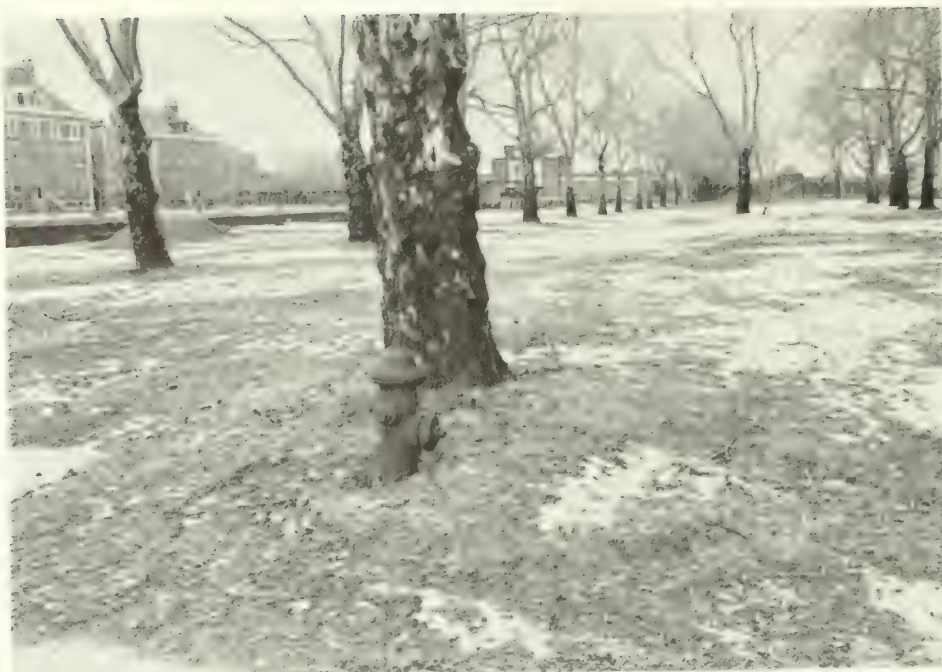
Fire hydrants, typical of those in New York City at the time, are in the landscape. Their installation date is unknown. They are in good condition but need painting (photo 27). Two manhole utility cover types occur in the landscape, one round, one rectangular. During this study, neither type could be removed to see what they cover. These elements may be among the oldest above grade objects on Ellis Island, possibly predating the existing main building. Their condition is good but rust is present on them (photos 28 and 29).

27. Fire hydrant.

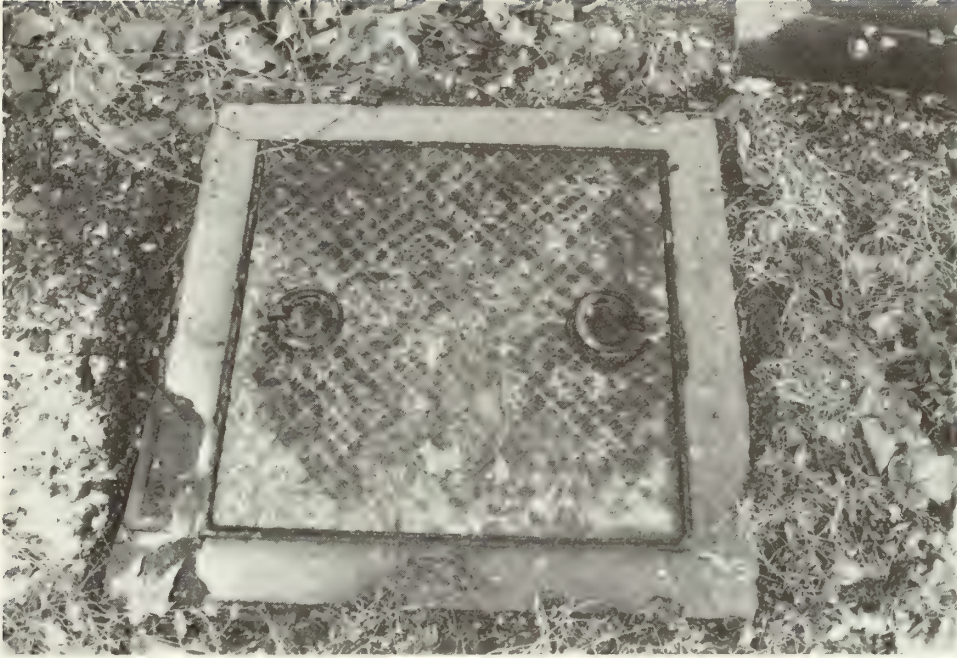
28. Manhole cover.

29. Manhole cover.

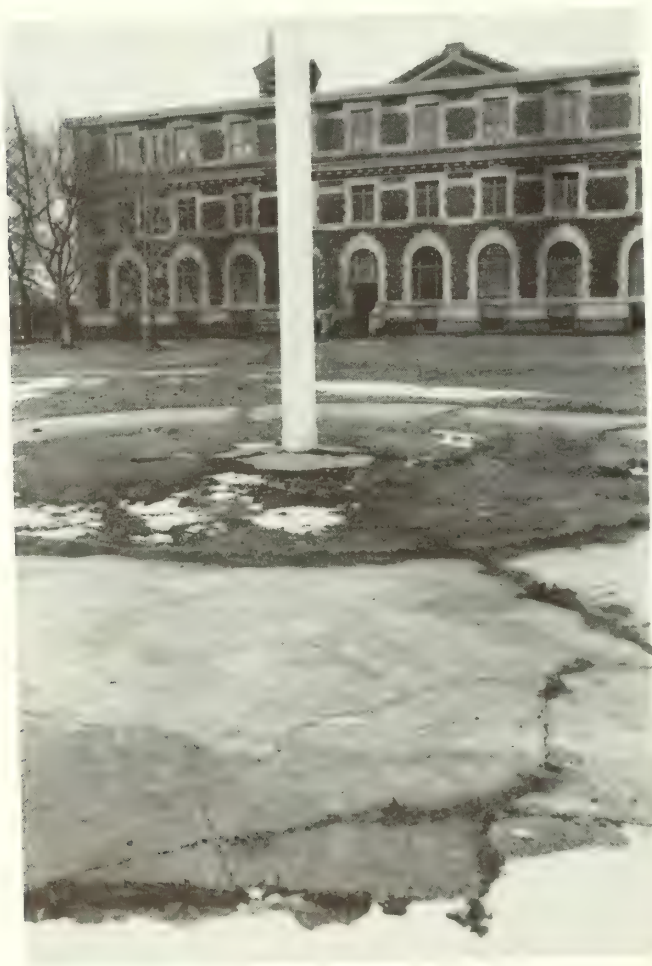
The flagpole at the tip of "the point" and the remnant concrete apron around its base date from 1937. The metal flagpole, painted white, is in good condition (photo 32).

32. Flagpole at the tip of the "point".

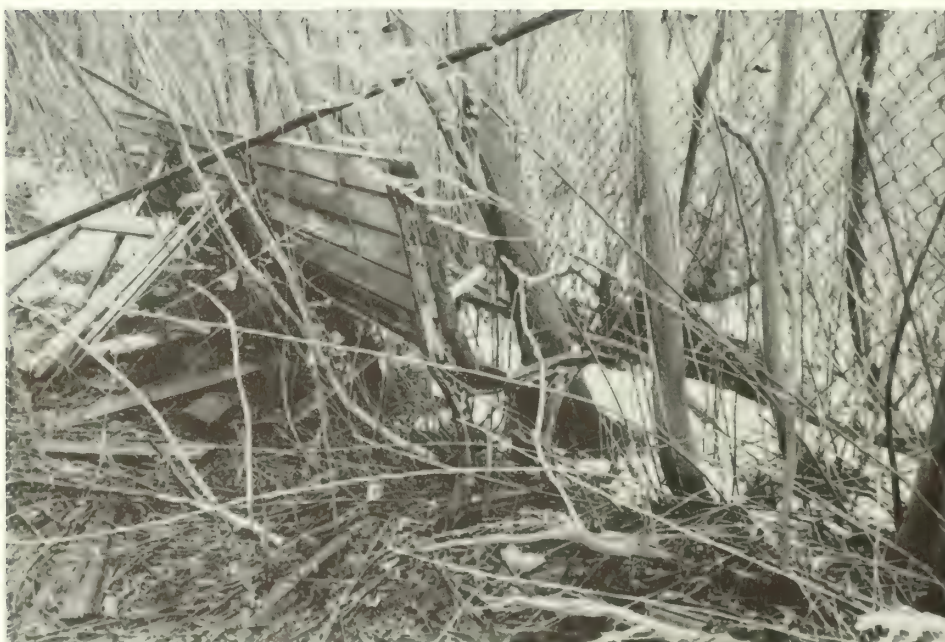
are 1 inch x 4 inch wooden slats without spacing (photo 34). This bench is the same as is seen in a circa 1914 photograph of the lawn area.

None of these benches is in good condition, but their metal support systems are intact and stable.

34. Bench.

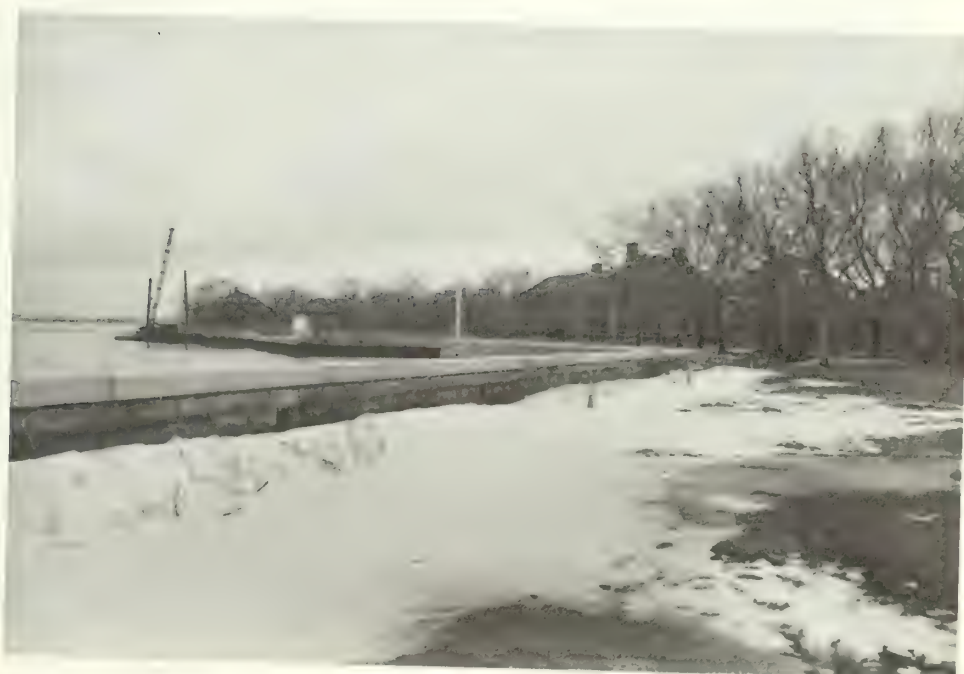
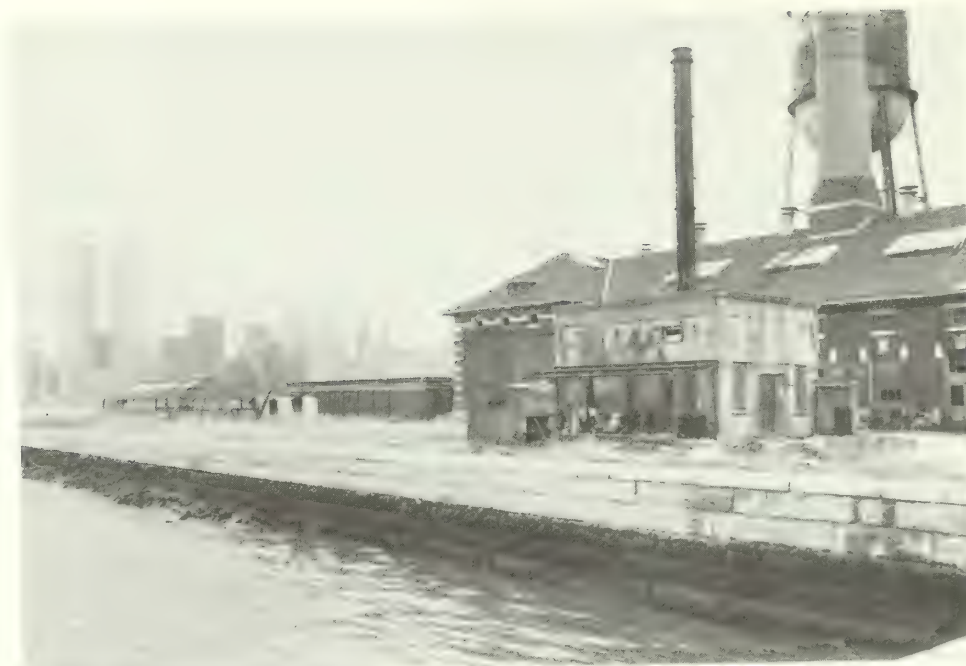
The granite seawall, begun in 1913, finished in 1935, and in the process of reconstruction since 1976, is in good condition. The wall top elevation above landscape grade varies from 0 to ± 4 feet (photos 40 and 41).

40. Seawall, east end of island 1.

41. Seawall, west end of island 1.

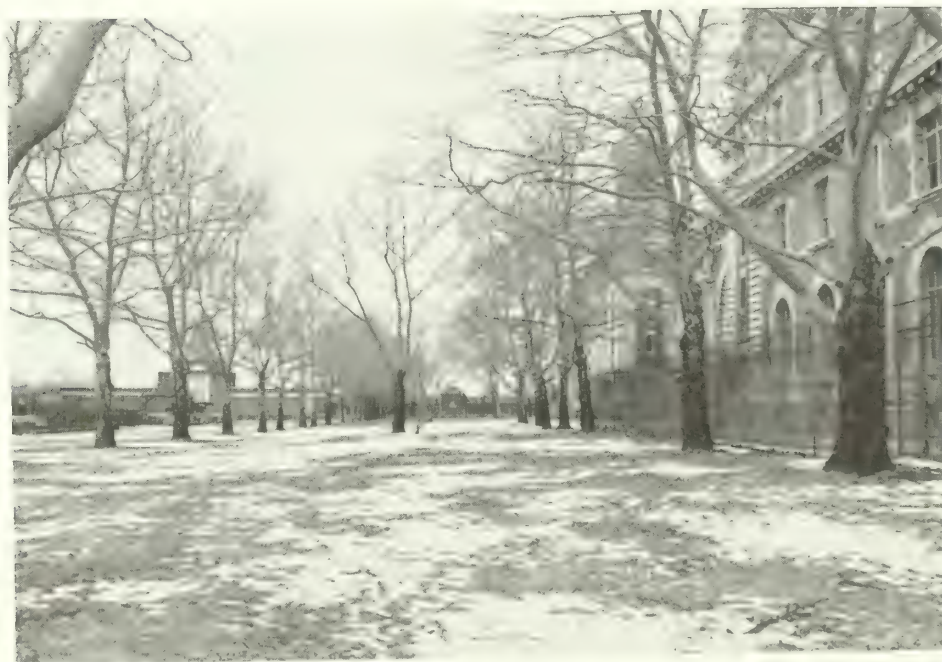
42. London plane trees in front of the main building.

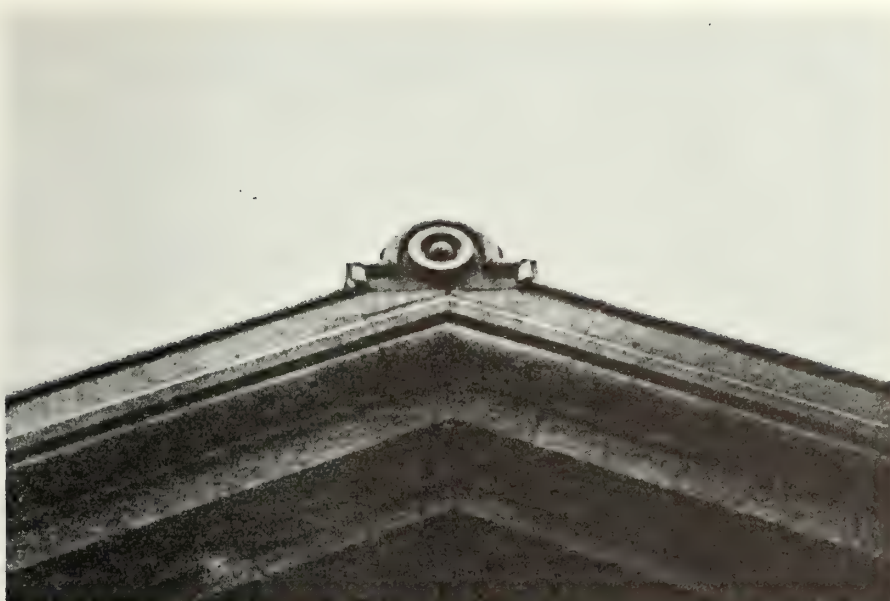
23. Copper cheneau, clerestory roof.

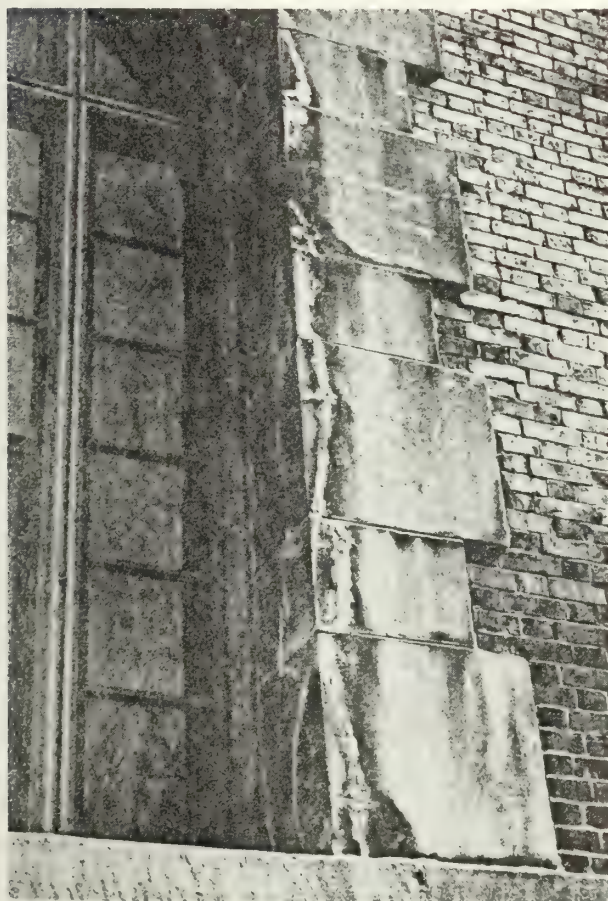
Cracking has occurred in the first and second story limestone window enframements, random areas of cornice work, and in isolated banding blocks. It is characterized by narrow fractures of variable length and direction, which range in width from 1/32 inch to 1/4 inch (photo 24).

In most cases, cracking appears to be the direct result of the expansive internal pressures of actively corroding iron or steel reinforcements and anchors. This process has been hastened by the subsequent action of increased water penetration and freeze-thaw cycling. In the case of the first and second story window enframements, the specific cracking of each individual limestone block can be directly attributed to the threaded iron bolts that were left in the stonework after the removal of the iron window grilles in the 1960's. In several areas, severe cracking has resulted in detachment and loss of large fragments of stone exposing both the bolts and their lead sleeves. The most extensive cracking has occurred in areas where excessive water penetration has saturated the walls.

24. Cracking at first story window enframement.

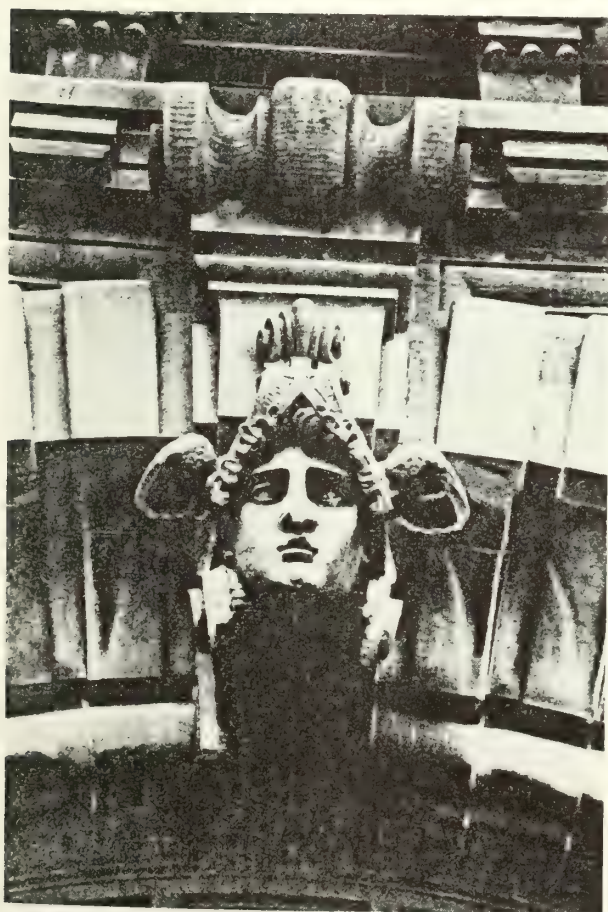
A black uneven staining is found on the limestone and granite in protected and semi-protected areas such as the cornice soffits (photo 28). In some cases, accumulative deposition has led to the formation of framboidal crusts of carbon soot, organic material, and calcium carbonate and calcium sulfate. This black crust is primarily a complex mixture of gypsum, carbon and other airborne particulates which are carried and deposited by wind and water (rain and fog). Areas of high exposure do not retain these surface deposits due to rain water washing.

28. Black crust on decorative sculpture.

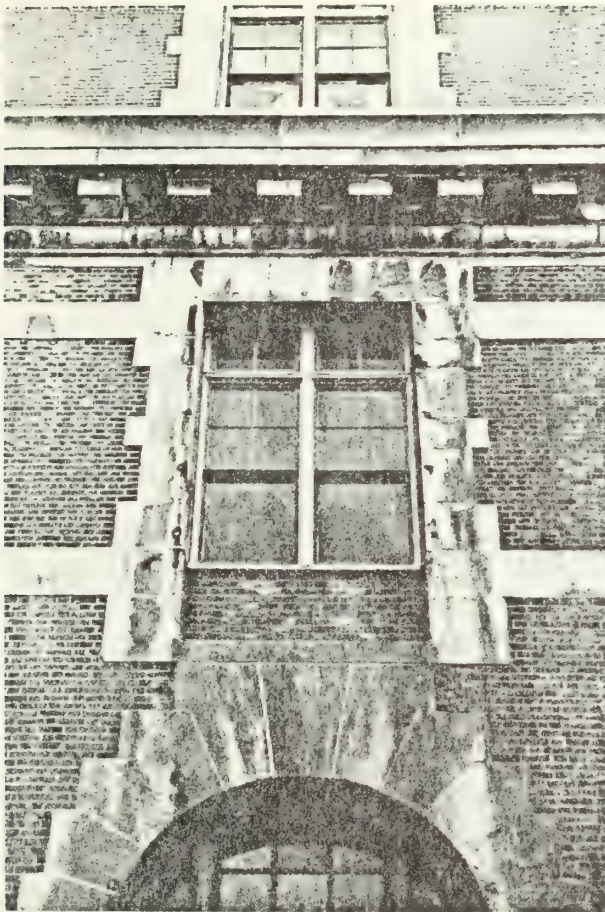
Biological staining appears in protected damp areas of stone and brickwork. This mottled green, brown, or grey staining can be attributed to the growth of algae and fungi (photo 29).

29. Biological staining in protected damp area.

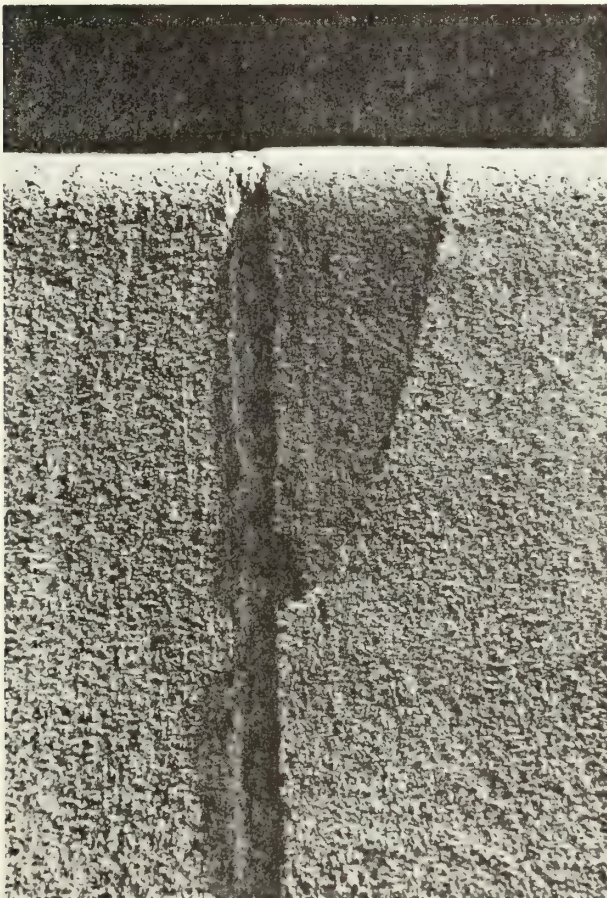
To date, a large number of patches and mortar fills exist on the building's exterior (photos 36-38). These represent a long history of repairs and alterations beginning with the repair of scarred defective limestone during the original construction. The most recent masonry repairs were undertaken by the Ehrenkrantz Group in 1980-1981.

36. Patching executed during the original construction.

37. Previous repair.

38. Previous restoration work.

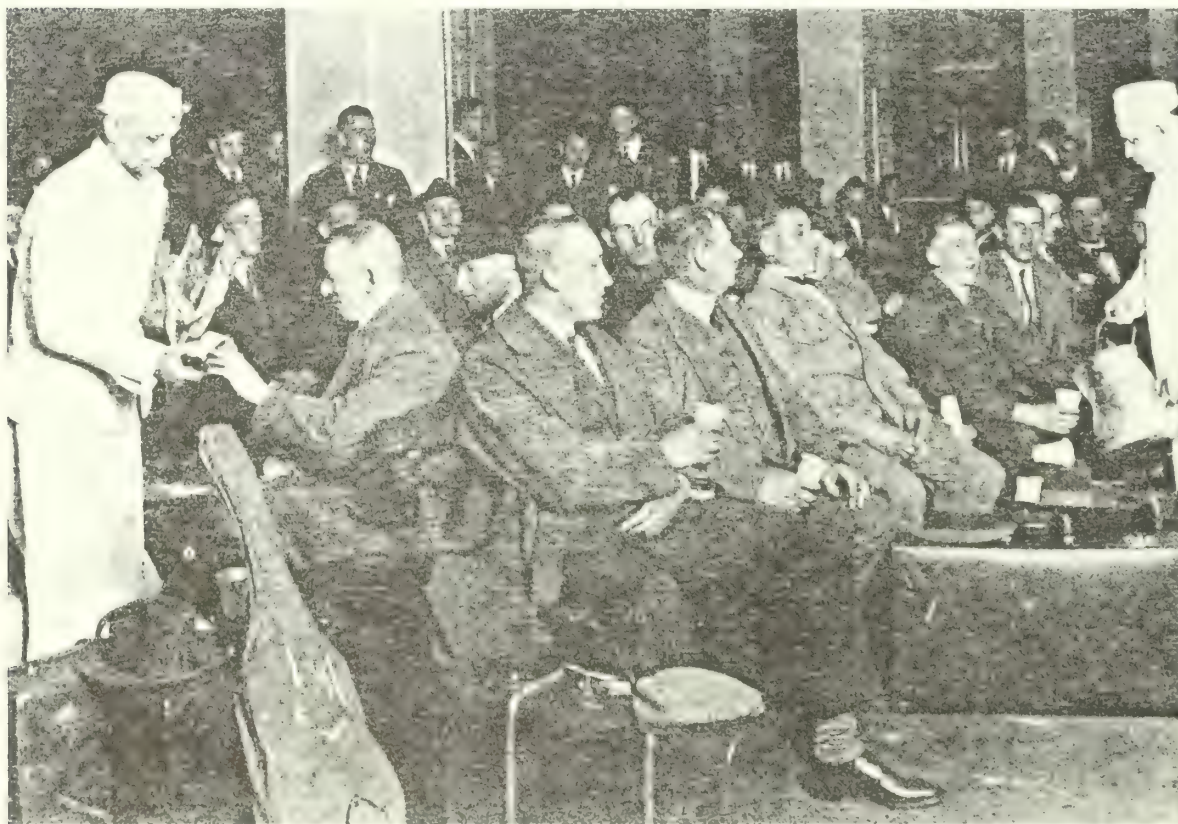
2. Baggage room, view northwest. "Refreshments, Awaiting examination, noon hour, June 1, 1926.". National Archives.

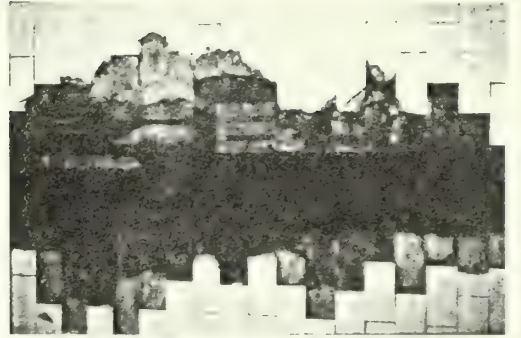
DESTROYED

0-30% intact.
Material is completely missing or is destroyed beyond practical retrieval.

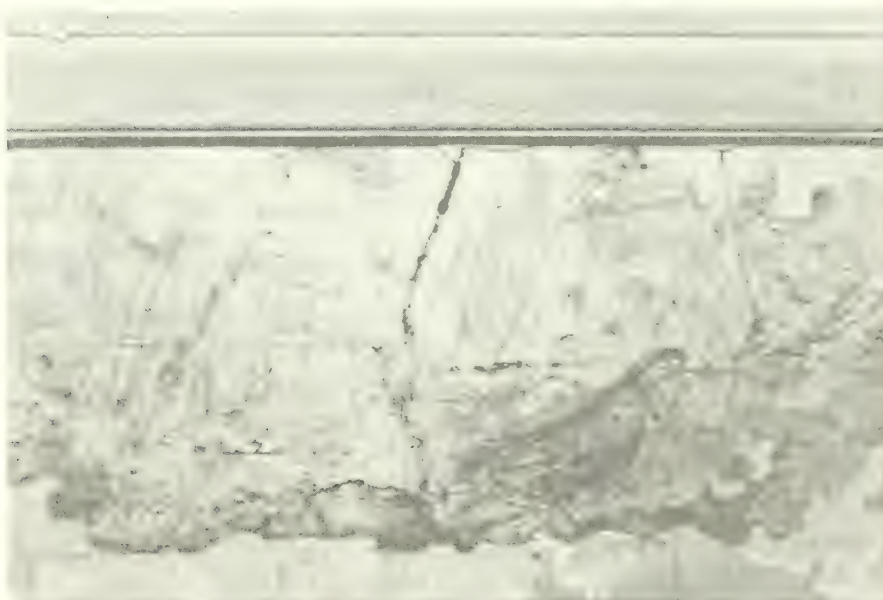
12. Graffiti on west wall, room 219.

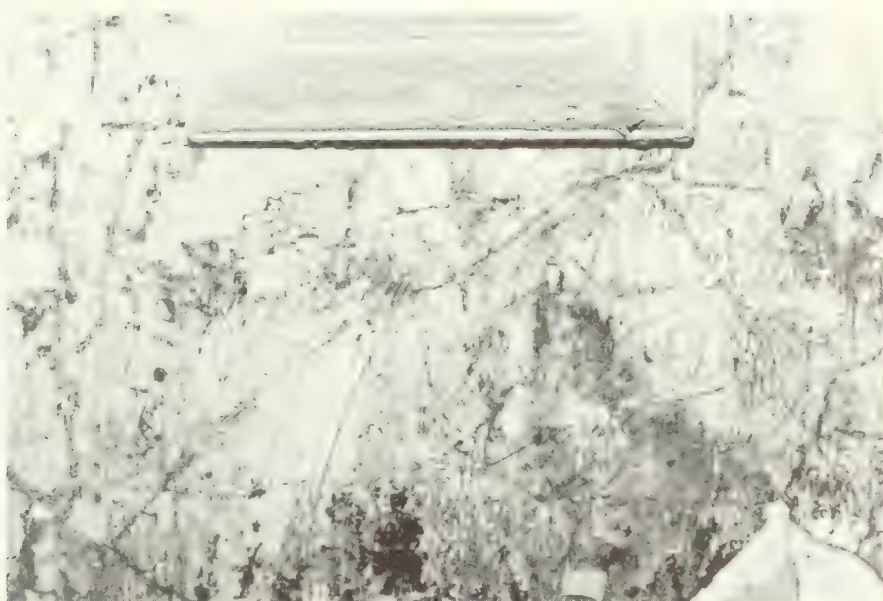
13. Room 219, graffiti on west wall.

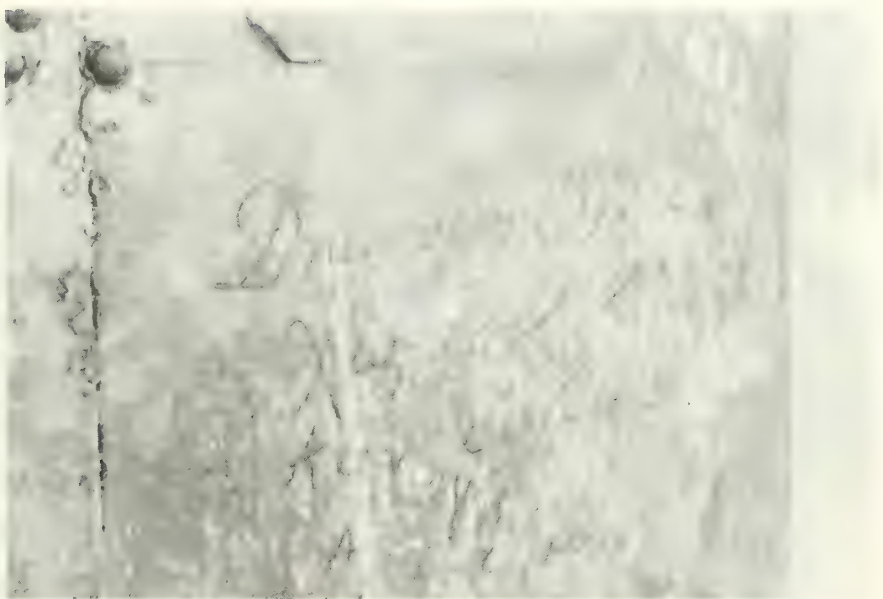
14. Room 303, graffiti on door.

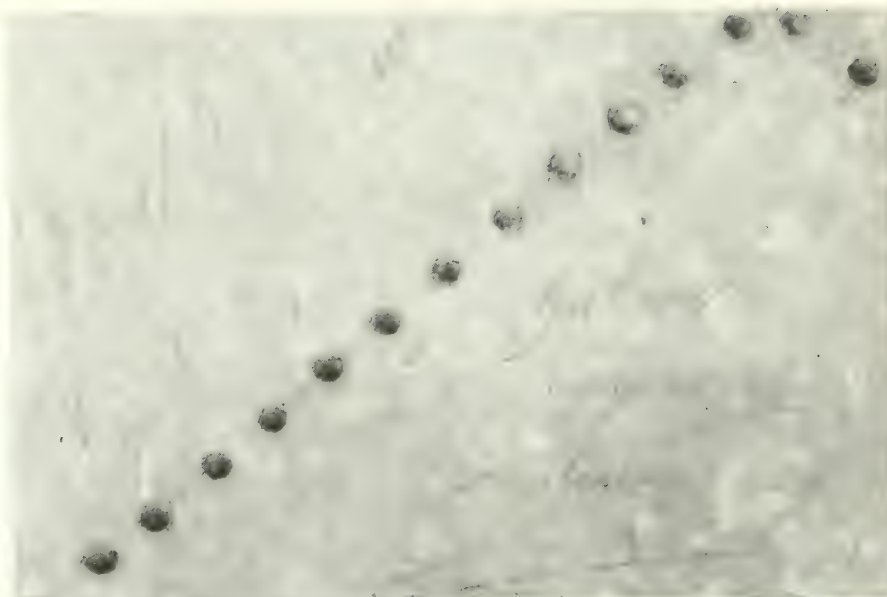
15. Graffiti on door, room 308.

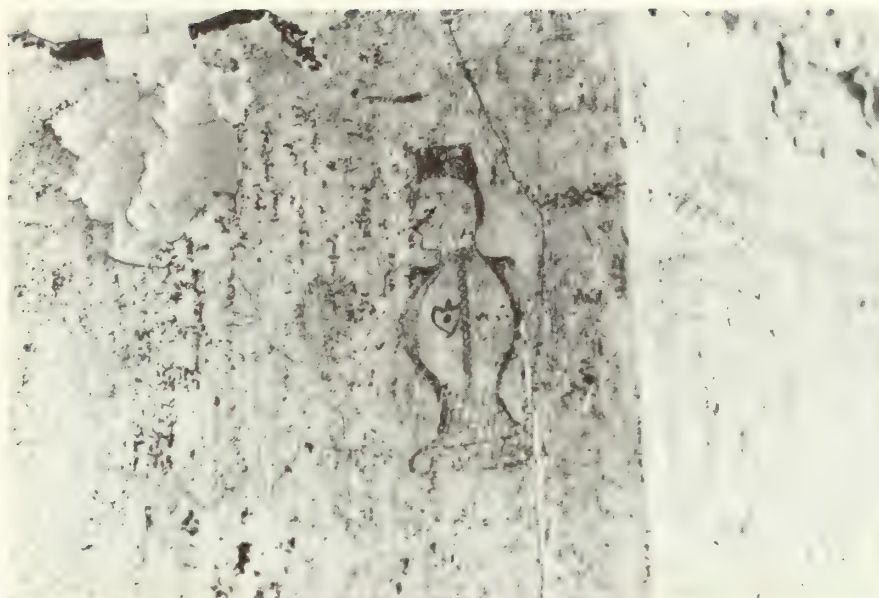
| 310 | - | octagonal column (photo 17) |

17. Drawing and graffiti on octagonal column, room 310.

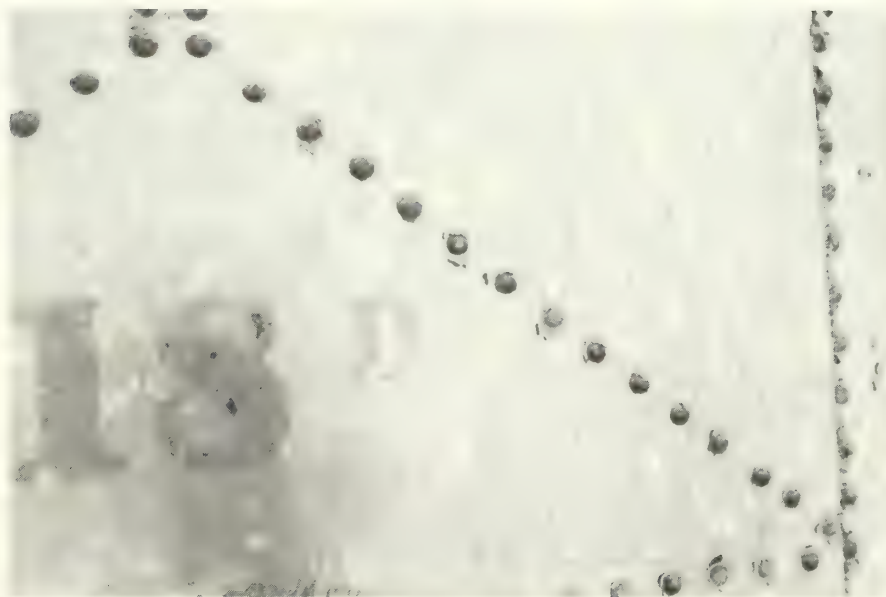
20. Graffiti on door, stair 15, room 303.

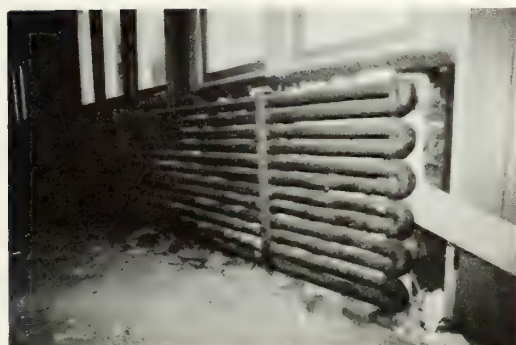
3. Exposed steam risers and pipe clusters, ca. 1905-7, railroad ticket office.

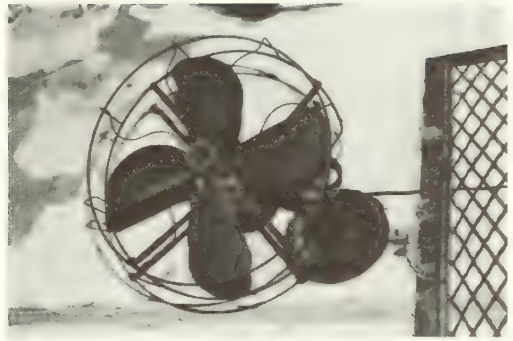
8. Wall mounted fan, room 226.

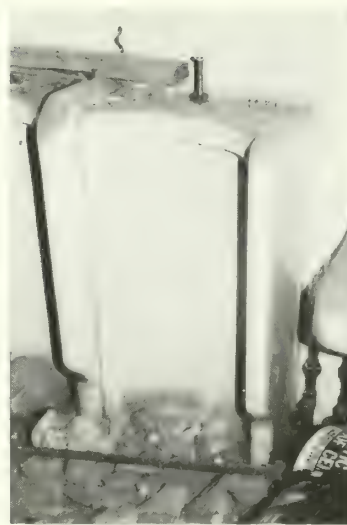
15. Urinal, 1924, room 233.

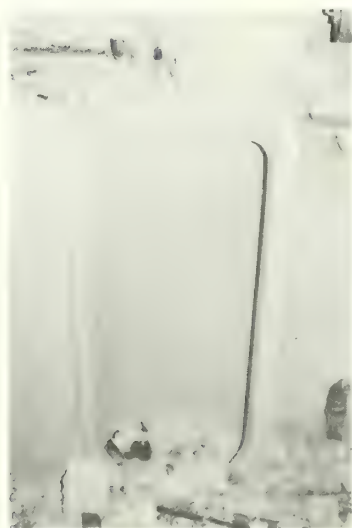
16. Urinal, room 133.

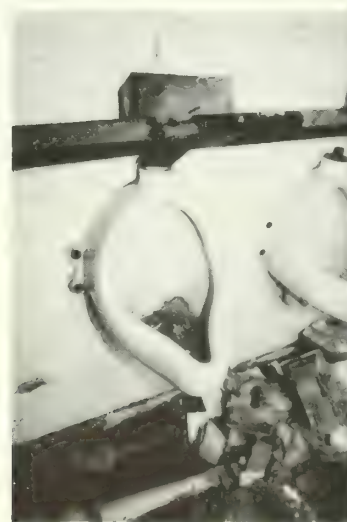
17. Urinal, 1940's, room 123.

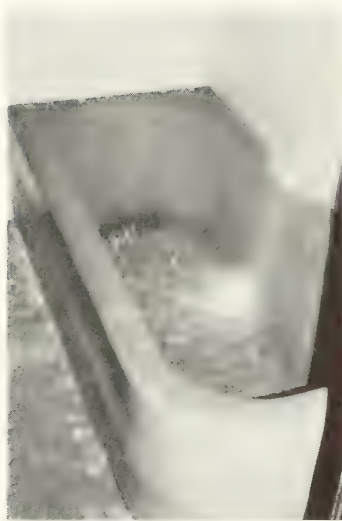
18. Bathtub, ca. 1924, room 324A.

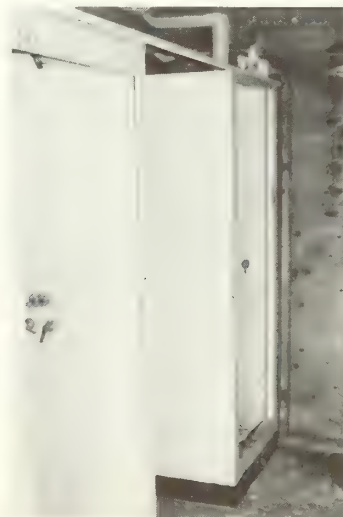
21. Aluminum stall showers, 1940's, room 304.

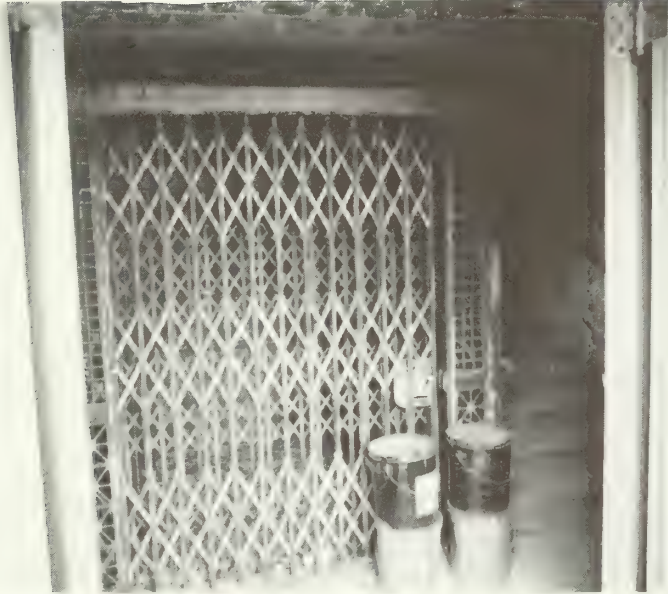
The elevator machine including the drum, brake and motor are very deeply rusted. There appears to be green copper oxide in the motor winding area. All of the ferrous metal control components are also badly rusted. There is wet dirt, rubble, and leaves in the pit and the machine area. The cab is below the bottom (rear, ground level) landing, where the door to the yard was open. The gates are rusted to the extent that access to the cab is not

1. Northeast tower elevator, view south from ground level entrance.

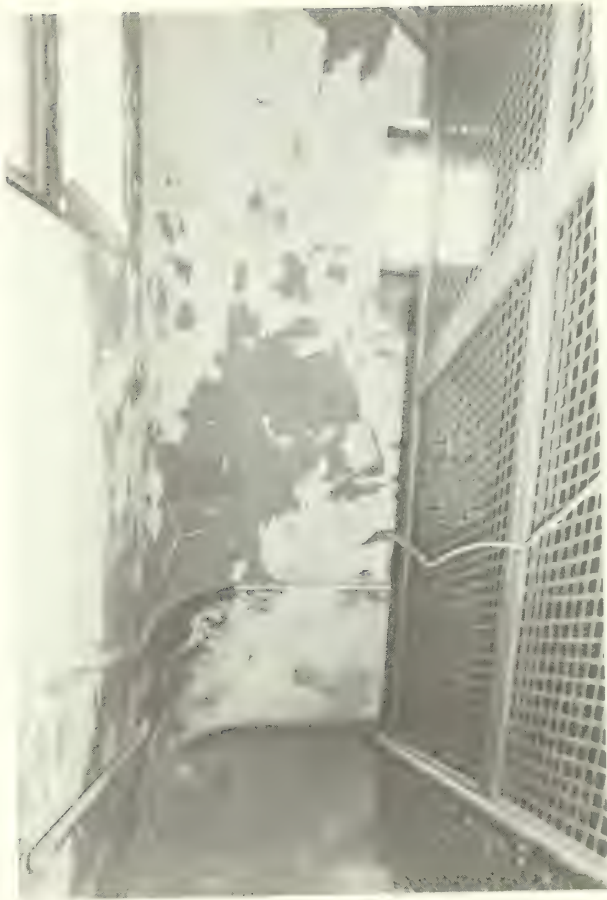
3. Northeast tower elevator (S03), view north.
